3rd Party Equipment

RECENTLY I WAS OUT ON A RIG HERE IN SE NEW MEXICO INSPECTING FOR SAFETY ISSUES WHEN I SAW THE FIRST PICTURE YOU SEE HERE.

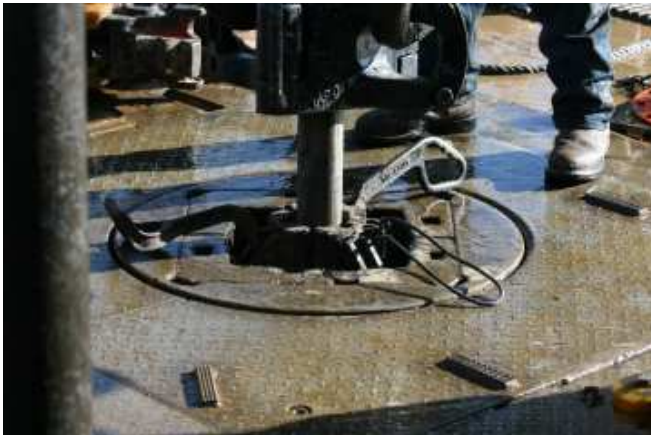
ROPES SUBSTITUTED FOR SLIP HANDLES IS BAD PRACTICE. I CAME OUT ON THE FLOOR AND QUESTIONED THIS ISSUE. SINCE THEY WERE TRIPPING WITH 3 ½ " DRILL PIPE I FIGURED THESE WERE RENTAL SLIPS.

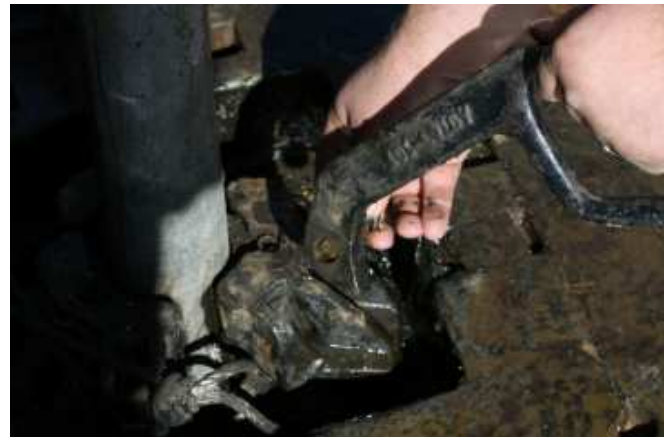
THE RIG MANAGER REACHED DOWN TO CHECK THE PIN ON THE REMAINING SLIP HANDLE AND THE PIN CAME OUT IN HIS HAND. 2 OF THE 3 SLIP HANDLE PINS WERE THE WRONG SIZE. AS YOU SEE IN THIS PICTURE THE PIN HEAD EASILY PASSED THROUGH THE HOLE. WE IMMEDIATELY REPLACED THE SLIPS WITH A SPARE PAIR.

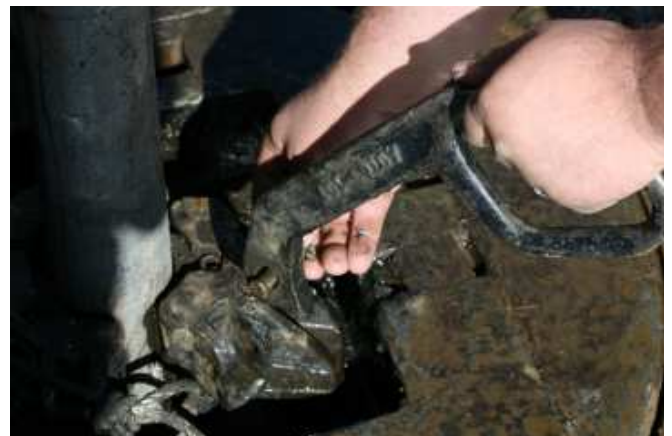
IF THE SLIP HANDLE HAD FALLEN INTO THE HOLE WE WOULD HAVE HAD AN EXPENSIVE FISHING JOB. THIS IS ONE GOOD REASON TO INSPECT 3RD PARTY EQUIPMENT.

MAINTAINING EQUIPMENT PROPERLY IS GOOD SAFETY PRACTICE ON A DRILLING RIG.
