Smashed Truck Cab

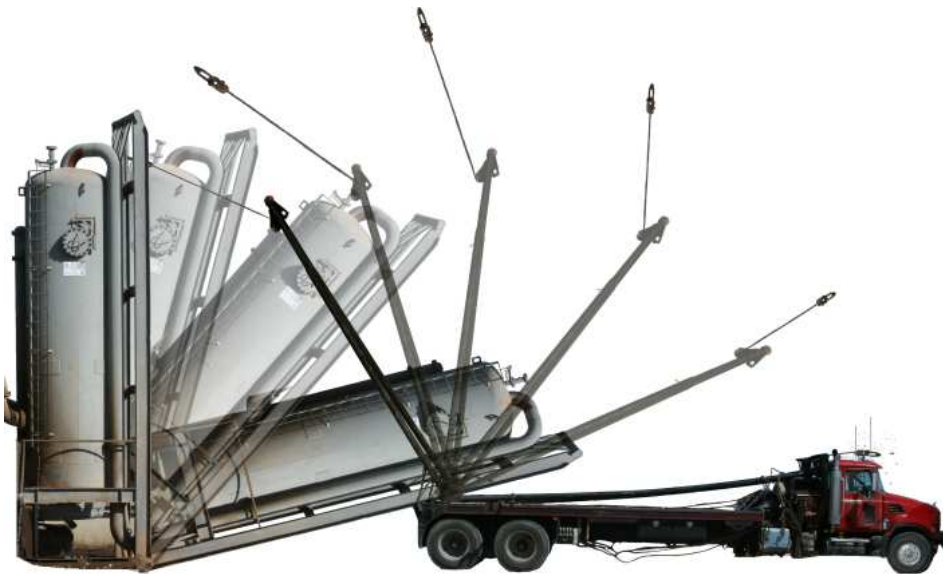
RECENTLY A TRUCK DRIVER JEOPARDIZED HIMSELF BY TIPPING OVER THIS SEPARATOR ONTO HIS TRUCK. THE POINT OF ATTACHMENT GAVE WAY AND HIS RIGGING SMASHED THE CAB OF HIS TRUCK.

THE PROBLEM WAS IN THE POINT OF ATTACHMENT. THE SWAMPER WRAPPED THE LOAD CHAIN AROUND THE CENTER BRACE (4" WELDED PIPE) AND LET THE CONNECTION SLIDE UP TO THE TOP SKID BAR.

THE EFFECT OF THE LINE BREAKING FREE UNDER TENSION WAS TO SLINGSHOT THE GIN POLES AND THE RIGGING OVER ONTO THE CAB OF THE TRUCK.

OBVIOUSLY THE CENTER BRACE IS NOT A GOOD STRESS POINT FOR MOVING THIS HEAVY SEPARATOR. EQUIPMENT THIS LARGE SHOULD ONLY BE MOVED BY CRANE OR A SAFER METHOD USED.

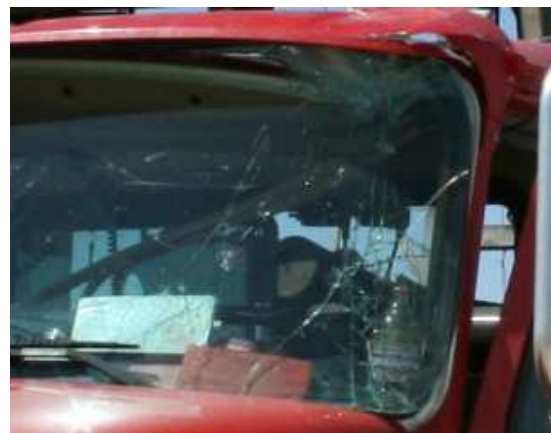
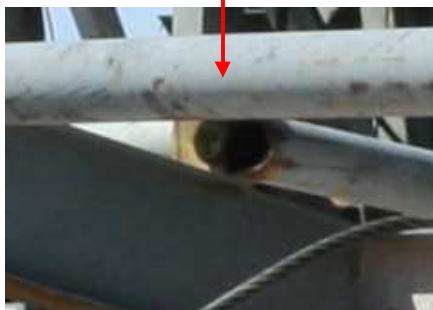
THE WELD ON THE CENTER BRACE BROKE LOOSE WHICH CAUSED THE LINE TO BREAK FREE. THE BRACE APPEARED TO BREAK FREE FROM THE WELD.
